Condition Assessment

Reserve Fund Plan

**KINGS PARK WEST**

Fairfax, Virginia

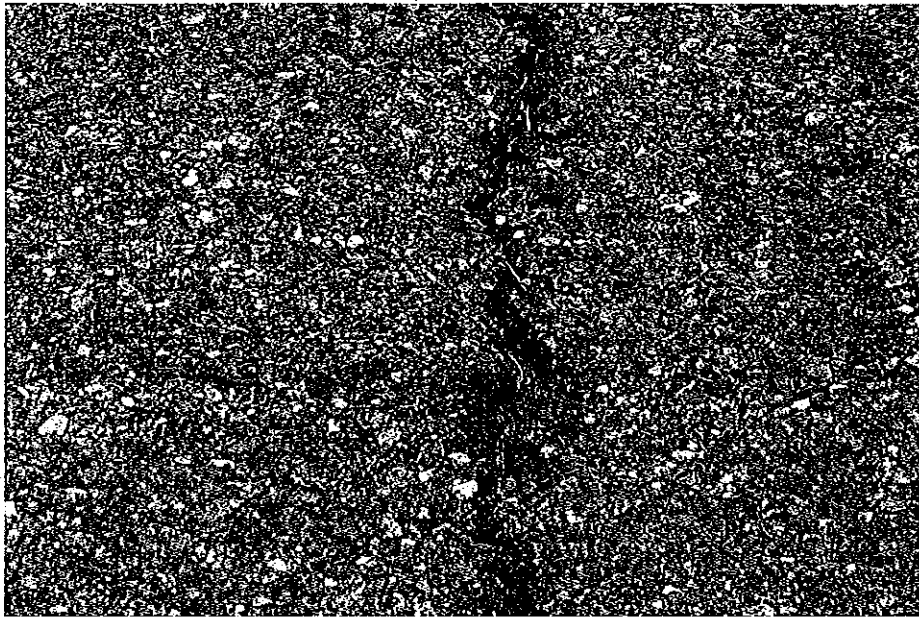
**PHOTO #1**  
Random longitudinal cracking is beginning to appear particularly along the main axis of most driveways. These open cracks require crack filling maintenance prior to application of seal coat

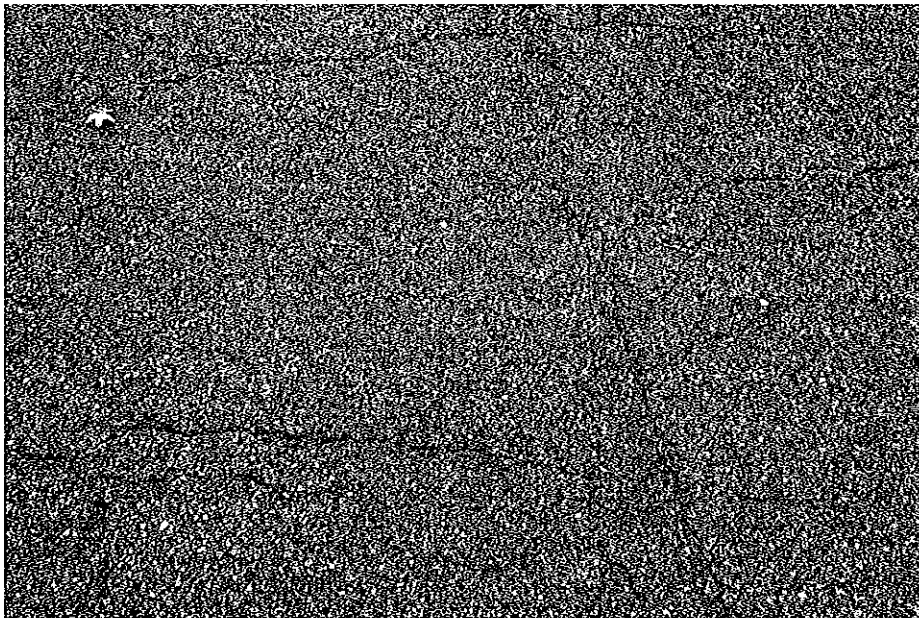
1.3	Asphalt Full-Depth Repair & Crack Filling Allowance	1	LS	\$30,000.00	\$30,000	6	2007	50%	\$15,000	2013	75%	\$27,749	2016	100%	\$41,089	Deflected pavement (approximately 260 square yards), indicative of sub-base damage, was observed in three streets and the pool parking lot. Random longitudinal and transverse cracking (approximately 3,550 linear feet) were observed throughout the community. Repairs are essential in order to achieve the projected remaining useful service life of the pavement. Full-depth repairs and crack filling are generally scheduled progressively every six years throughout the study period, including the year of the asphalt restoration project. See the Asphalt Pavement Supplemental Report, Section 8, for additional details. Refer to Photo #1 and #2 and Maintenance Protocols 7.3 and 7.4.

**PHOTO #2**  
Deflected pavement, indicative of sub-base damage, is beginning to appear along the main axis of most driveways. Full-depth repair is required prior to application of seal coat

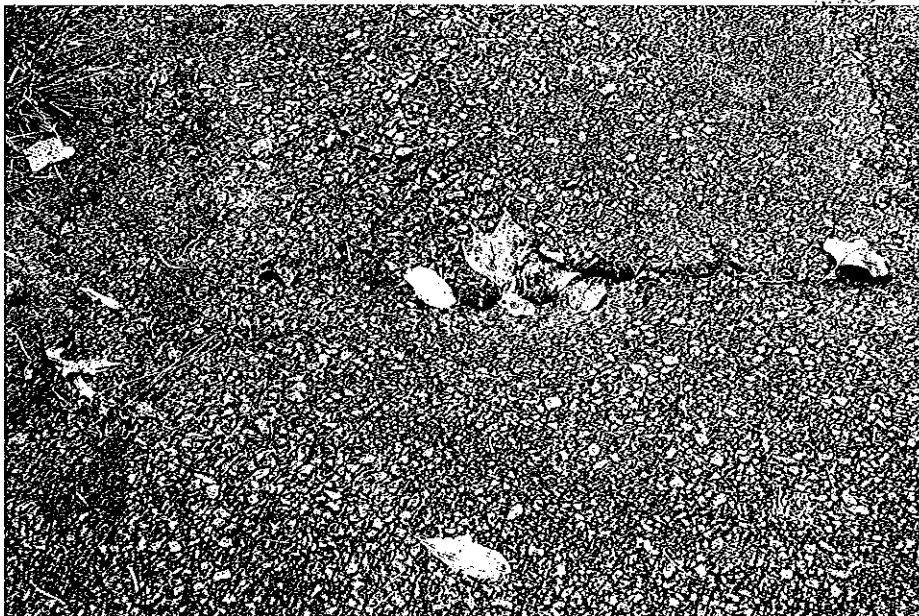
1.4	Asphalt Footpaths	416	SY	\$30.00	\$12,480	12	2007	60%	\$6,240	2013	12%	\$1,847	2016	38%	\$6,495	Asphalt footpaths 3', 4', or 6' in width provide access between sections of the community. The footpaths range from like-new to poor condition. We have scheduled them for replacement according to condition with 50% (the 3' wide paths) in poor condition near-term, 12% fair to good condition mid-term, and 38% like-new condition late-term. The 3' wide paths have potholes, subsidence cracking and heaving causing tripping hazards. These should be replaced as soon as practicable to prevent personal injury. The footpath restoration project is scheduled to coincide with other asphalt projects to promote cost efficiencies. Refer to Photo #3 and #4 and Maintenance Protocol 7.5.
<b>2. CONCRETE COMPONENTS</b>

**PHOTO #3**  
Older damaged sections of asphalt footpath requiring replacement near-term

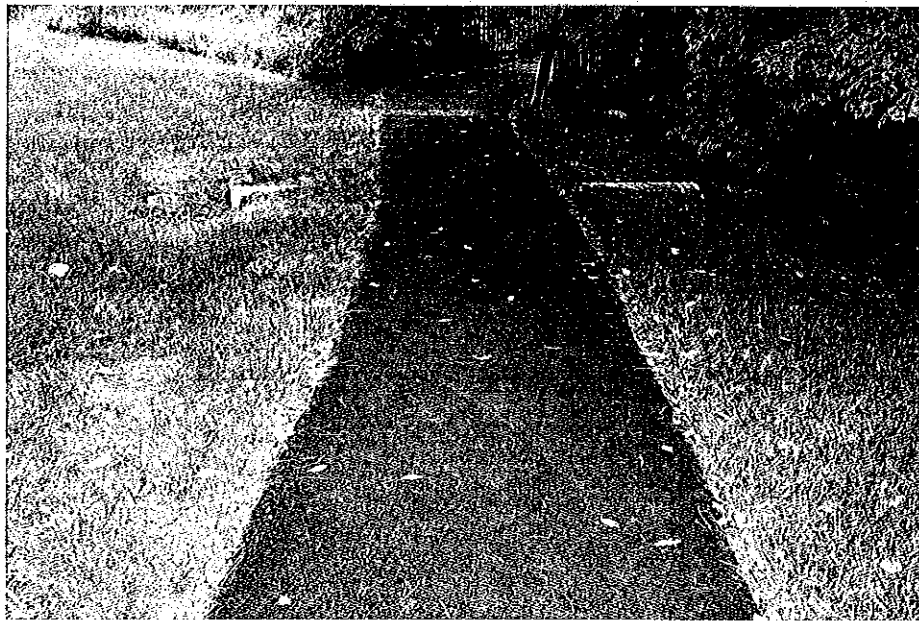
**PHOTO #4**  
Recent overlay  
replacement of a major  
section of asphalt  
footpath appearing to be  
in good condition

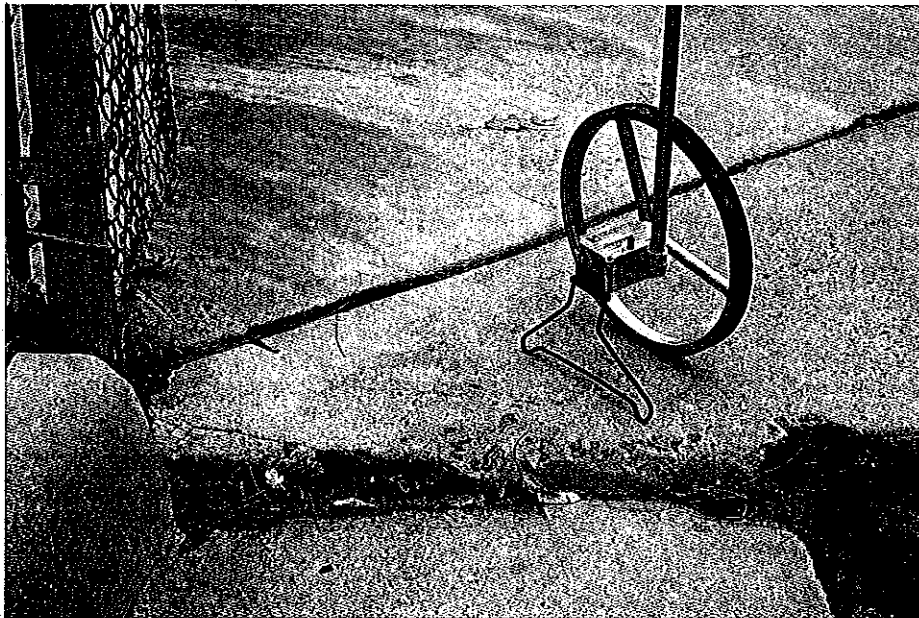
**PHOTO #5**  
Differential settlement of  
adjacent concrete  
components resulting in a  
large tripping hazard  
requiring repair at the  
pool entrance

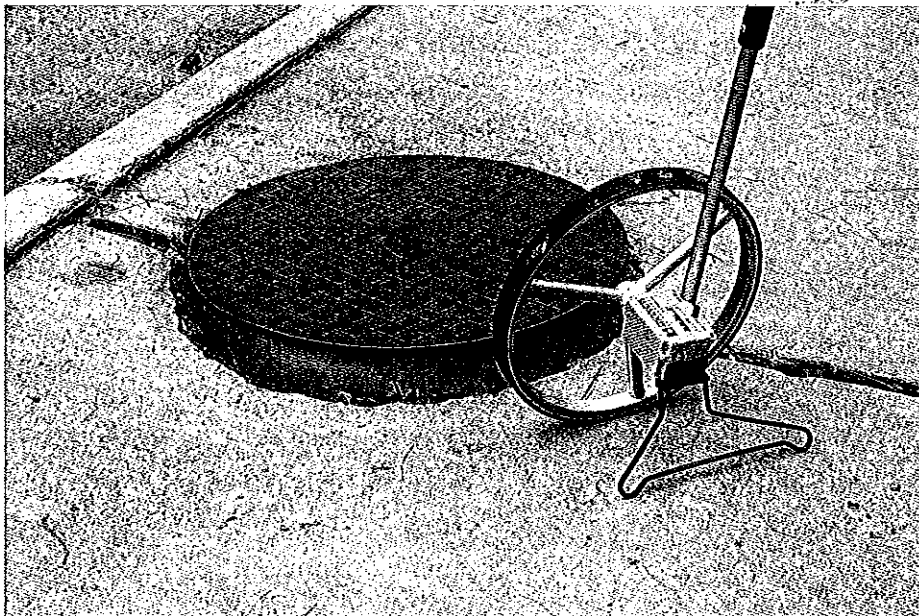
**PHOTO #6**  
Settlement of concrete  
flatwork at a utility cover  
resulting in a large  
tripping hazard requiring  
repair. Seven problem  
areas were observed

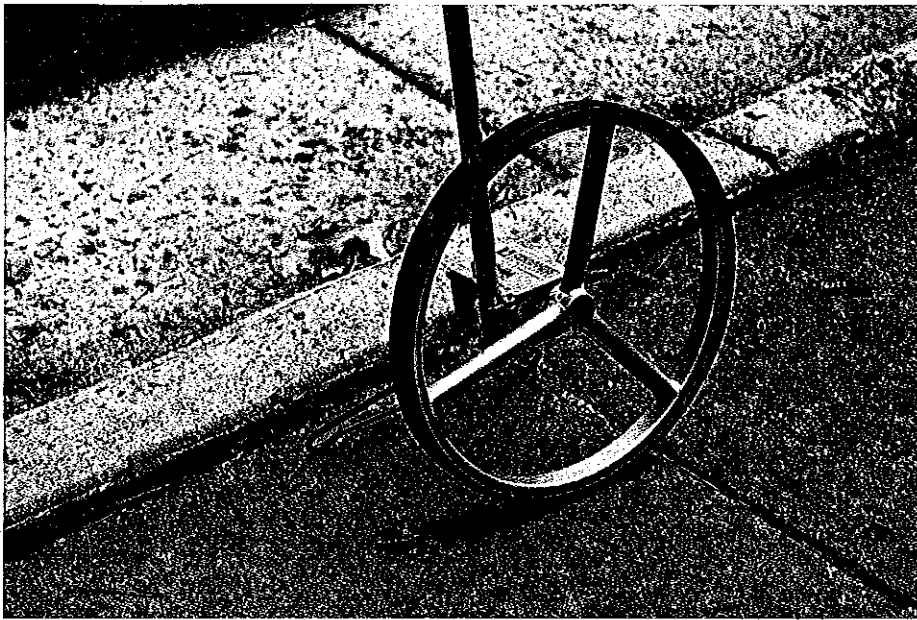
**PHOTO #7**  
Differential settlement of flatwork adjacent to a curb resulting in a tripping hazard requiring repair

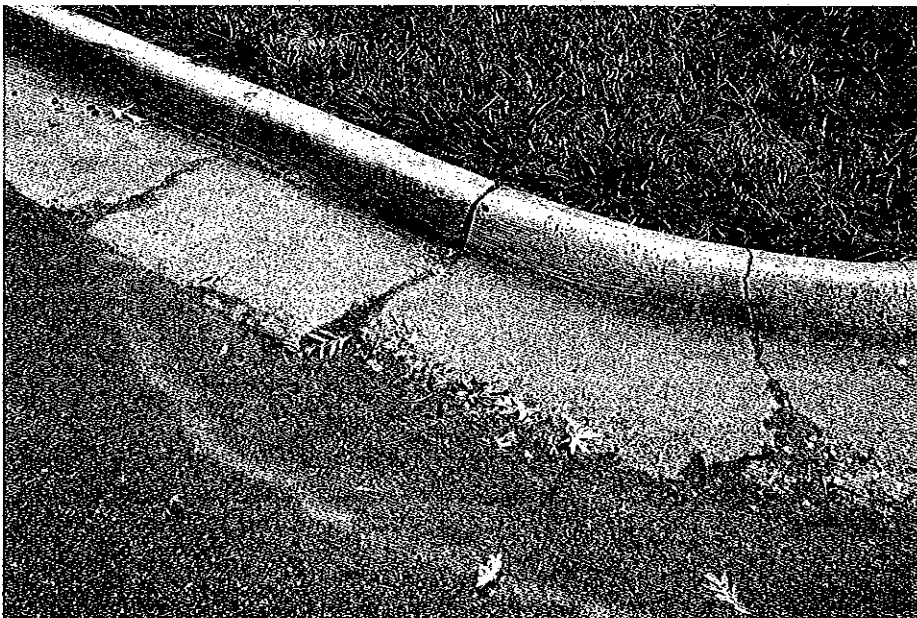
**PHOTO #8**  
Impact damaged curbs requiring replacement

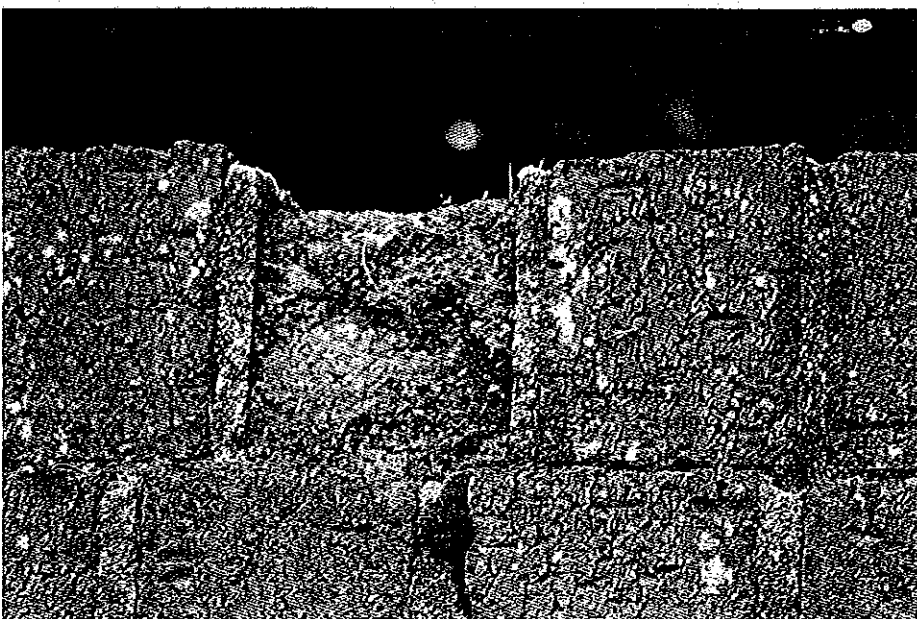
**PHOTO #9**  
Deteriorating brick coping on the main entrance monument requiring replacement under the operations budget to maximize service life

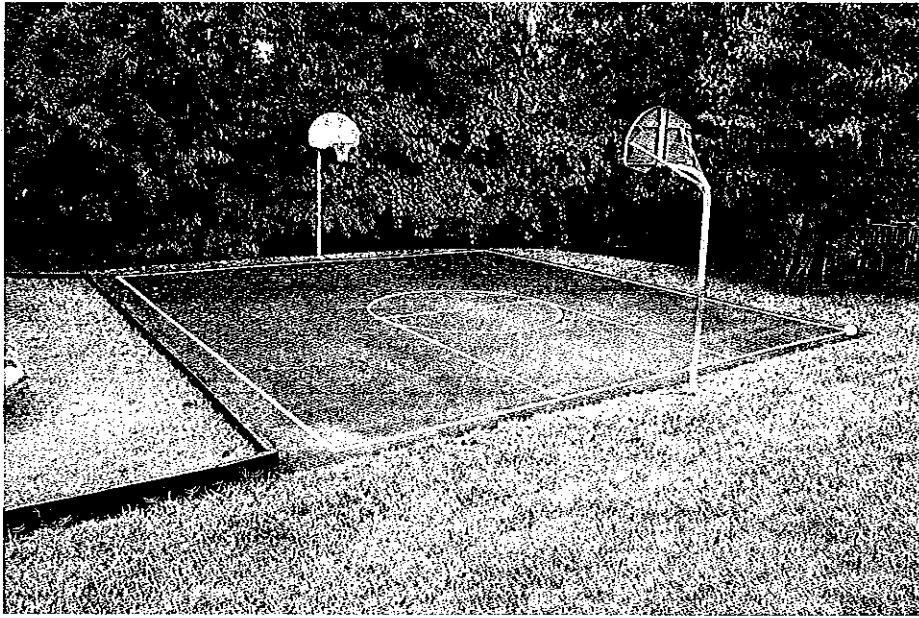
**PHOTO #10**  
Overview of the multi-purpose court in good condition, having been overlaid in the recent past. The metal backboards would benefit from cleaning and painting to help stop the rust

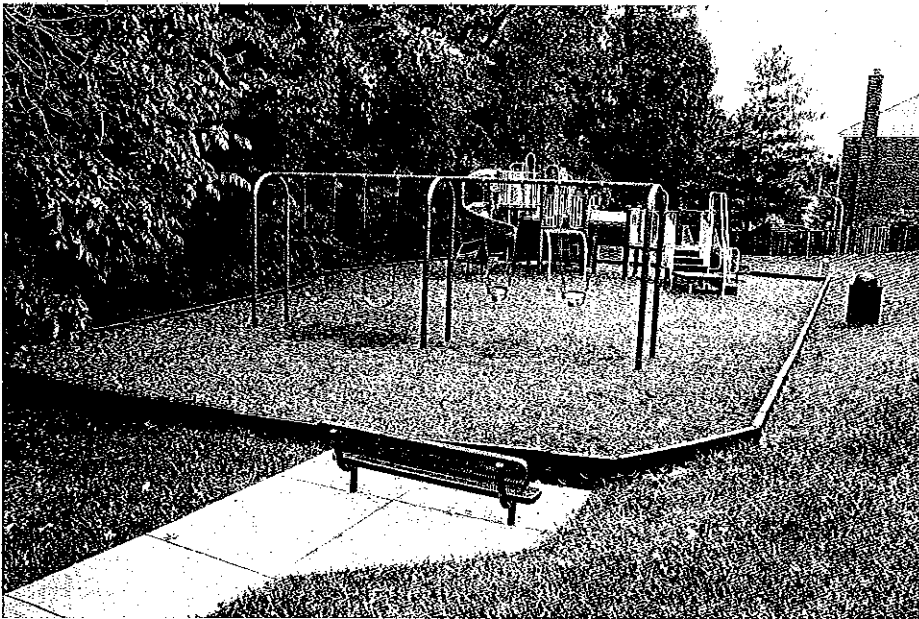
**PHOTO #11**  
Overview of the tot lot, although not new, appearing to be in continuing good condition

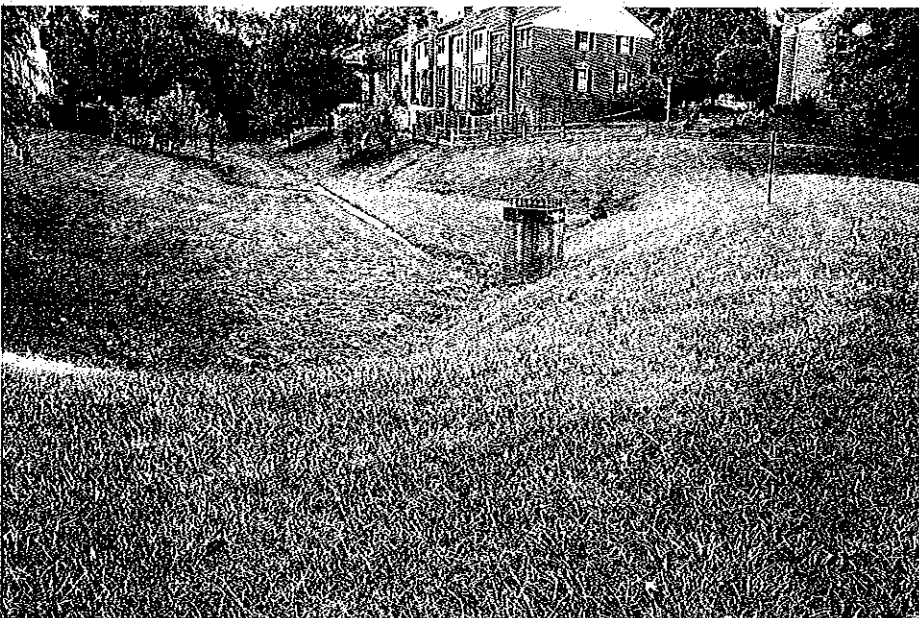
**PHOTO #12**  
Overview of the larger of two storm water management ponds with earthen impoundment structure, concrete overflow riser, and concrete swales, all appearing to be in good condition

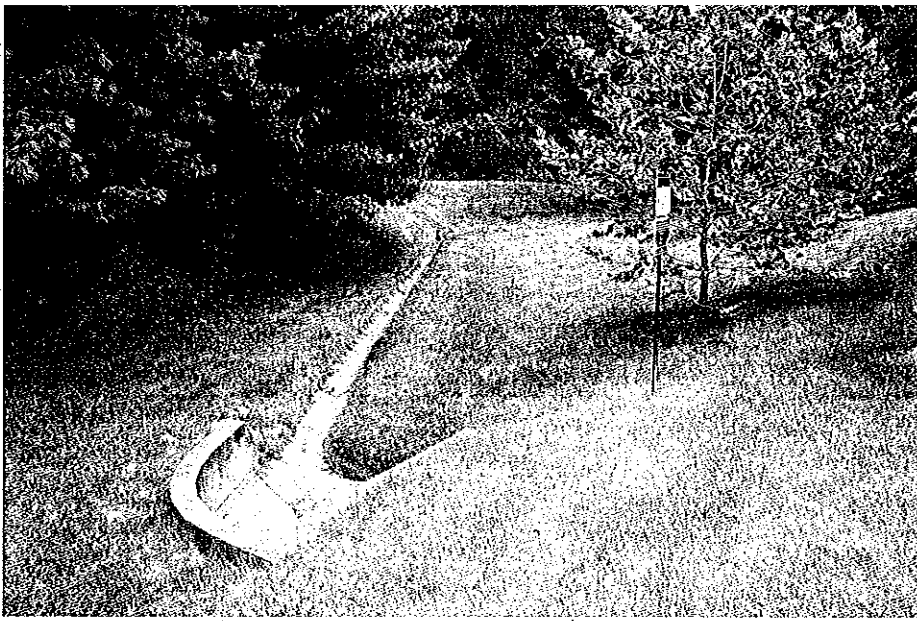
**PHOTO #13**  
Smaller of the two storm water management ponds with outfall, concrete swales, and an earthen impoundment structure

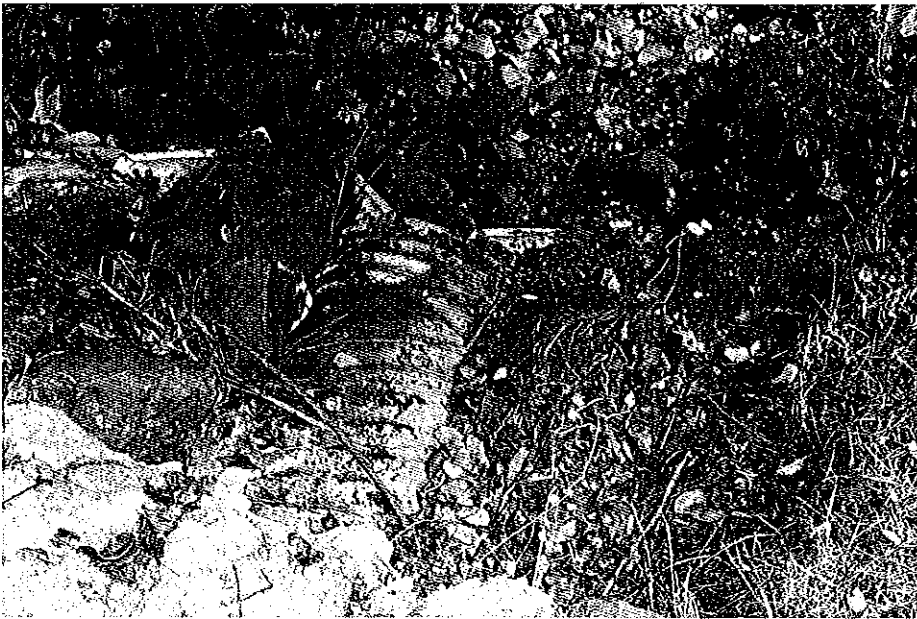
**PHOTO #14**  
Footpath corrugated metal culvert near the tot lot in deteriorating condition. Several areas along the stream will require remediation

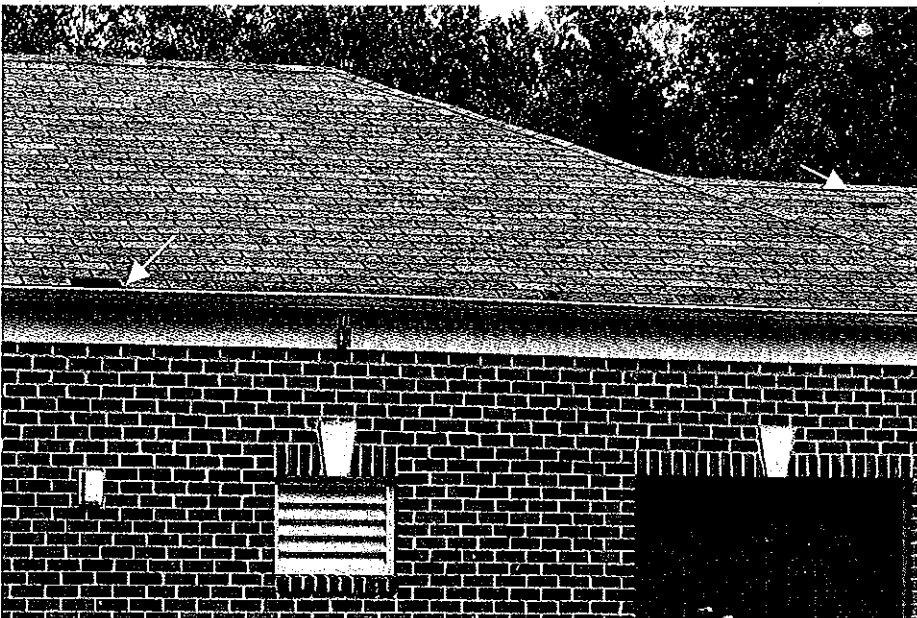
**PHOTO #15**  
Detail of the pool building roofing. Shingles appear to be in generally good condition, but the roof requires maintenance including replacement of missing shingles

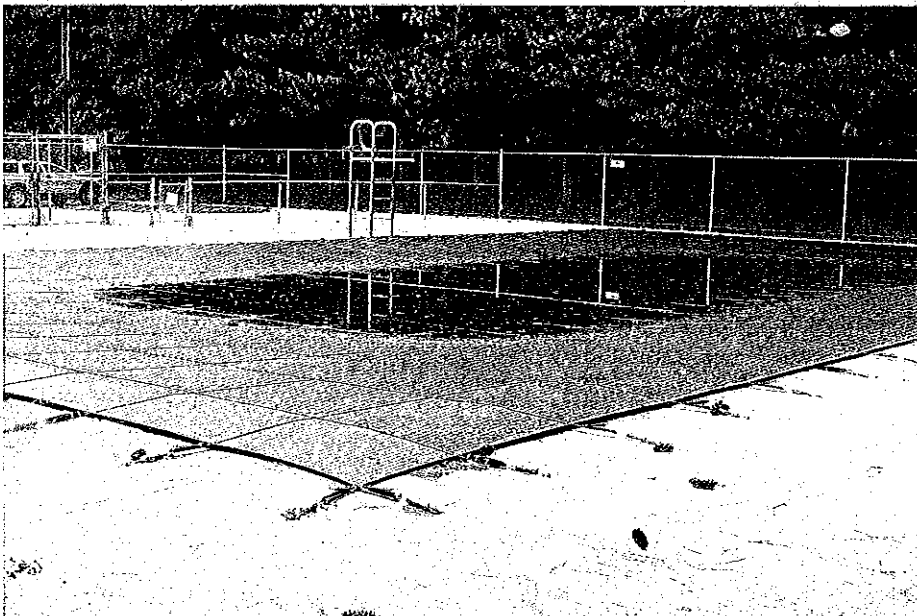
**PHOTO #18**  
Overview of the main pool with seasonal cover to help protect the pool
